MARYLAND HISTORICAL TRUST NR-ELIGIBILITY REVIEW FORM

Property Name: Good Fellowship Inventory Number: HO-190					
Address: 1795 Woodstock Road City: Woodstock Zip Code: 21163					
County: Howard USGS Topographic Map: Sykesville					
Owner: Davis Branch Estates, LLC					
Tax Parcel Number: 225 Tax Map Number: 10 Tax Account ID Number: 03-292223					
Project: Davis Branch LLC Agency: U.S. Army Corps of Engineers					
Site visit by MHT Staff: X no yes Name: Date:					
Eligibility recommended Eligibility not recommended _ X_					
Criteria: ABCD Considerations:ABCDEFGNone					
Is the property located within a historic district? x no yes Name of district:					
Is district listed?noyes Determined eligible?noyes District Inventory Number:					
Documentation on the property/district is presented in: MIHP form prepared by Cleora Barnes Thompson, Office of Planning & Zoning, Howard County Comprehensive Planning Section, 1977.					
Description of Property and Eligibility Determination: (Use continuation sheet if necessary and attach map and photo)

Description Summary

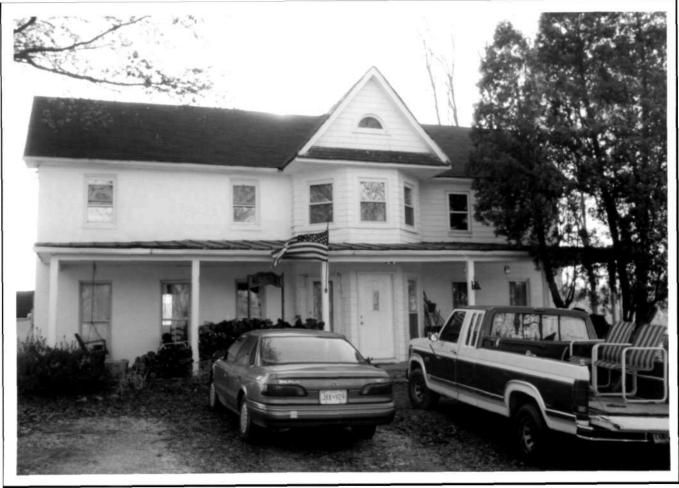
#1 of 7

The façade of the stone portion of the building has three bays on the lower level and two in the upper story. The first floor openings contain two-over-two light, double-hung, wood-sash windows. The sills of the first-floor windows are wood. The second story openings are smaller and contain one-over-one light, vinyl-sash windows. The two windows are in alignment with the outer openings of the first level. There is no visual evidence of alterations to the lower openings, such as the removal of a door or the enlargement of the windows due to the heavy parging of the stone walls. A wood soffit trims the eave.

The three-sided bay is located slightly south of the center of the building. The first floor of the bay contains doors in both the center and left bays. Both doors are synthetic replacements, and appear recently installed with the removal of all trim. The right facet of the bay holds a one-over-one light, vinyl-sash window. The second level of the bay contains one-over-one light, double-hung, vinyl-sash windows in each facet of the bay. The second-story openings are trimmed with plain wood architraves. A cross-gable roof covers the bay. A half-round window pierces the gable of the attic level. The bay is sheathed in wood shingles.

The south portion of the façade is frame construction with one-over-one light, double-hung, vinylsash windows in the two bays of the first and second levels. All trim has been removed from the window openings. This section of the façade is covered with wood shingles. A hip-roofed porch shelters the first-floor openings of the façade. A stone foundation supports the flagstone paving of the porch, and chamfered wood posts brace the roof. The ceiling is covered with tongue-and-groove planking. The roof is sheathed with standing-seam metal.

MIHP # HO-190 DOOD FELLOWSHIP MYRTUE FARM HOWARD COUNTY, MD DEAN DOERDFELD, R.L. GOODWIN 23 NOVEMBER 2005 MD SHPD

Fagade

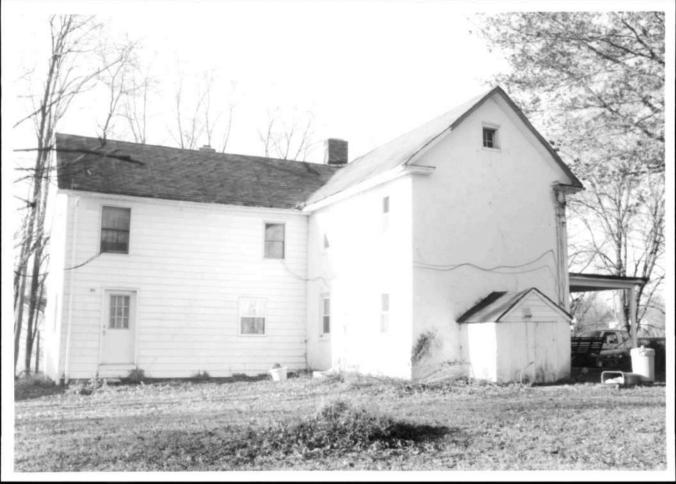
MIHP \$40-190 GOOD FELLOWSHIP MYRIVE FARM HOWARD COUNTY, MD DEAN DOERRELD, R. C. GODWIN 23 NOVEMBER ZUS MD SHPO NORTH ELEVATION #2 of 7

The north elevation of the stone section of the building has a single opening in the attic level. This four-light window is centrally located near the apex of the roof. The cornice returns slightly at the eave, and a half-story, parged-stone addition provides access to the cellar. The cellar addition is covered by a gable roof covered in composition shingles. Fenestration of the east elevation of the stone portion is symmetrical with a door flanked by two windows on the first floor, and two windows in the second floor. The second level openings are in alignment with the windows of the first floor. All the windows are one-over-one light, double-hung, vinyl sash, and the synthetic door contains a half-light with artificial muntins.

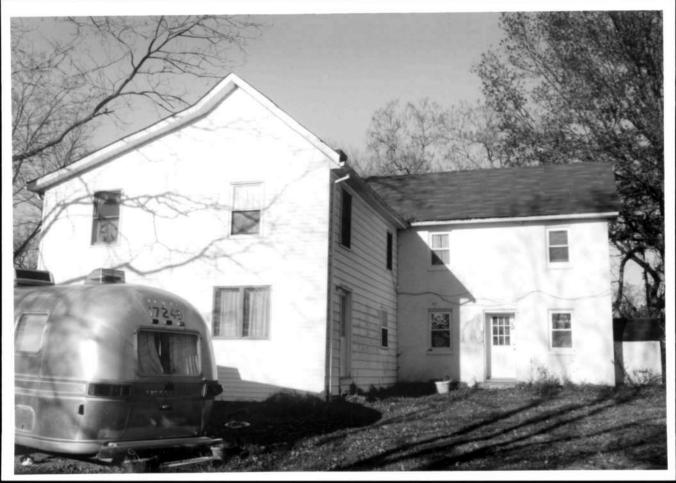
MIHP # HD-190 6000 FELLOWSHIP MYRTUE PARM HOWARD COUNTY MD DEAN DUEZZIFELD, R.L. GOODWIN 23 NOVEMBER 2005 MD SHPO EAST ELEVATION #3 017

The east wall of the frame addition suggests that a shed-roofed porch once extended from the south wall. The northern portion of the wall terminates in an asymmetrical gable roof while a shed-roofed section extends to the south. Two building periods also are suggested by a stone foundation supporting the gabled portion, and concrete under the shed. The first floor is pierced by a two-light, metal-sash casement window. The second floor contains a one-over-one light, double-hung, vinyl-sash window in

the gable portion and a similar window in the enclosed shed. This wall of the addition is sheathed in vinyl siding.

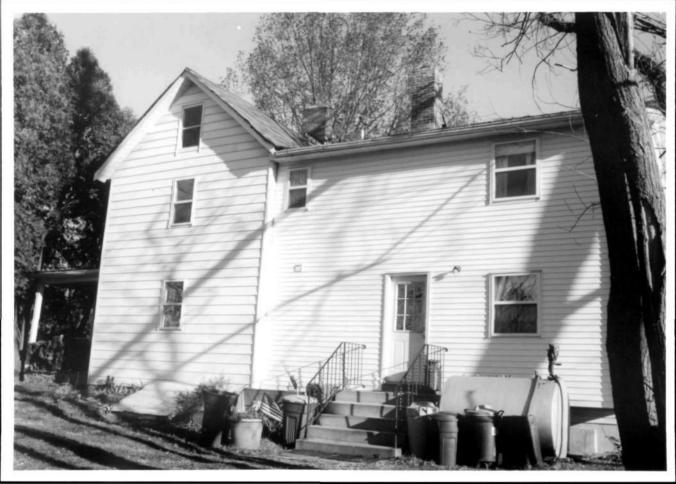
MIHP \$40-190 6000 PELLOWSHIP MYRTUE FARM HOWARD COUNTY, MD DEAH DOERRFELD, R.C. GOODWIN 23 NOVEMBER 2005 MD SHPO SOUTH ELEVATION #H of 7

The south elevation of the building displays the longitudinal wall of the addition, and the gable wall of the principal mass. The addition is stepped back about three inches from the plane of the gable wall, and is pierced by two openings on each level. Locations of the openings correspond to those of the opposite longitudinal wall: a door and window on the first floor and two windows on the second.

Synthetic materials comprise the frames, sash, and leaf of the doors and windows. Pre-cast concrete steps lead to the door. The gable wall has a centrally located window on both stories and in the attic. The attic window is a one-over-one light, double-hung, wood sash while the lower windows have the same light configuration but are constructed of vinyl. The south wall of the addition is sheathed in vinyl siding, and the south-facing gable wall is covered in aluminum siding. Two chimneys are visible from the south side of the house. An interior brick chimney pierces the ridgeline of the principal mass in the southern frame section. Previous investigations note a stone chimney between the south wall of the stone section and the north wall of the frame section. This chimney no longer exists, and an irregularity in the roof implies that it was removed. A second brick chimney rises from the south slope of the rear addition. Access to the interior of the building, which appears to currently support multiple dwelling units was not provided.

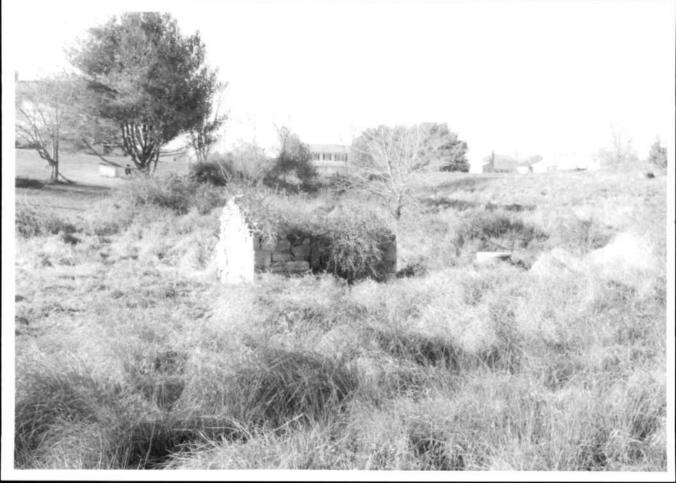
MIHP # 40-190 GOOD PELLOWSHIP MYRTUE FIRM HOWARD COUNTY, MD DEAN DOERZPELD, RL GOODWIN 23 NOVEMBER 2005 MD SHPU Rving of Springhouse #6 of 7

Good Fellowship contains eleven agricultural outbuildings. One building is stone with the remainder exhibiting frame construction. The stone building is the remnants of a springhouse at the origins of Davis Branch. The side-gable, square building is now partially collapsed. The frame buildings follow a farm lane that descends to Davis Branch south and east of the dwelling. Immediately east of the house stands a one-story, front-gable storage building with a shed-roofed addition. The building is clad in plywood and is accessed through a double-leaf plywood door with metal grilles. The addition is enclosed on three sides with corrugated-metal siding and pierced by two vinyl widows. Slightly south of the plywood storage building is a second outbuilding. This front-gable building is supported by a concrete foundation and is clad in T1-11 siding. Double sliding doors provide access on the north elevation. Two, multi-light metal-sash windows pierce the east wall. The roof is covered with corrugated-metal panels.

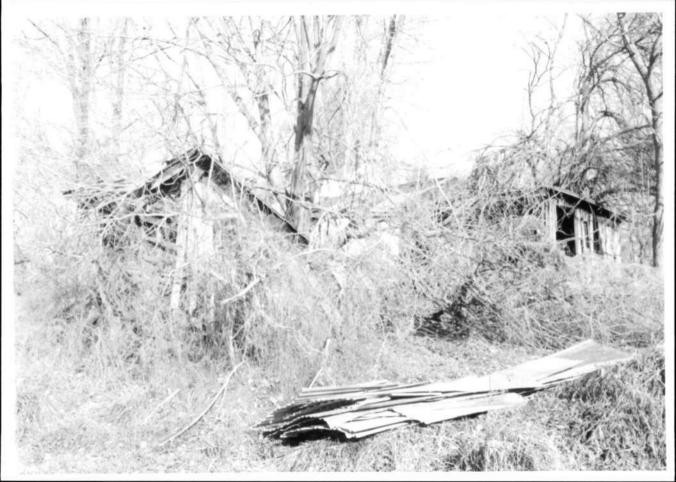
MIHP # HD-190 GOOD PELLOWSHIP MYPTUE FAIZM HOWARD COUNTY, MD DEXH DOERRPELD, RC GODWIN 23 HOVENBER 2005 MD SHPO RUINS OF POULIRY HOUSES #7 A 7

Two partially-collapsed buildings lay about 200 feet east of the house. These shed-roofed poultry houses are clad in vertical board siding, and the roofs are covered with metal panels.

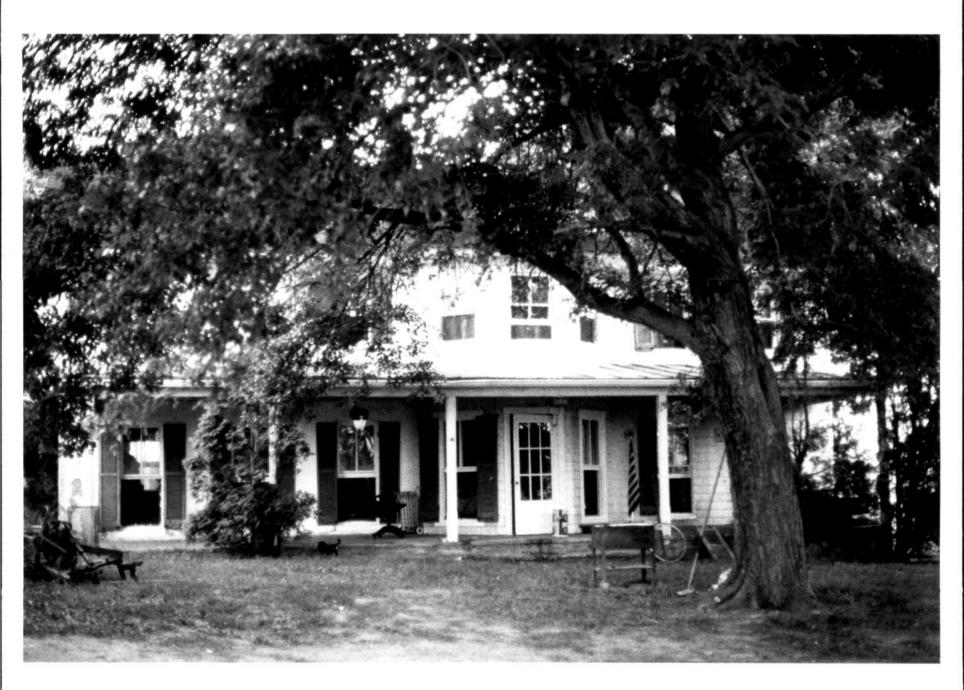
HO · 190 GOOD FELLOWSHIP WEST SEPT. 1977 CLEORA PLANNIN HISTORIA

The west elevation holds three first and two second floor rectangular double-hung windows, holding two-over-two lights and decorated with flat wooden sills and shutters.
